Esthetic Rehabilitation of a Patient with Dental Fluorosis using Porcelain Laminate Veneers - A Case Report

Case report: This case report describes rehabilitation of a moderate form of dental fluorosis using a conservative treatment approach with porcelain laminate veneers (PLVs). Porcelain laminate veneers provide better esthetics along with optimum functional strength.

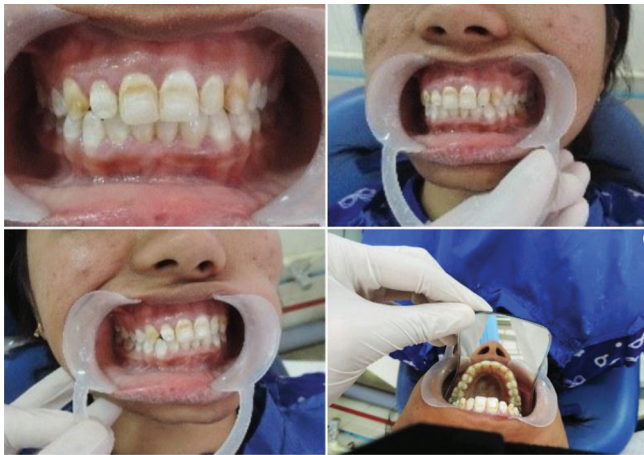
Figure-1: Types of Dental fluorosis

Classification	Criteria
Normal (0)	The enamel represents the usual translucent semivitriform-type of structure. The surface is smooth, glossy, and usually of pale, creamy white color.
Questionable (0.5)	The enamel discloses slight aberrations from the translucency of normal enamel, ranging from a few flecks to occasional white spots.
Very mild (1)	Small, opaque, paper white areas scattered irregularly over the tooth, but not involving as much as approximately 25% of tooth surface.
Mild (2)	The white opaque areas in the enamel of teeth are more extensive, but do not involve as much as 50% of tooth.
Moderate (3)	All enamel surfaces of the teeth are affected and surfaces subject to attrition show wear. Brown stain is frequently a disfiguring feature.
Severe (4)	All enamel surfaces of the tooth are affected and hypoplasia is so marked that the general form of the tooth may be affected. There is discrete pitting of the affected tooth. Brown stains are widespread and teeth often present a corroded-like appearance.

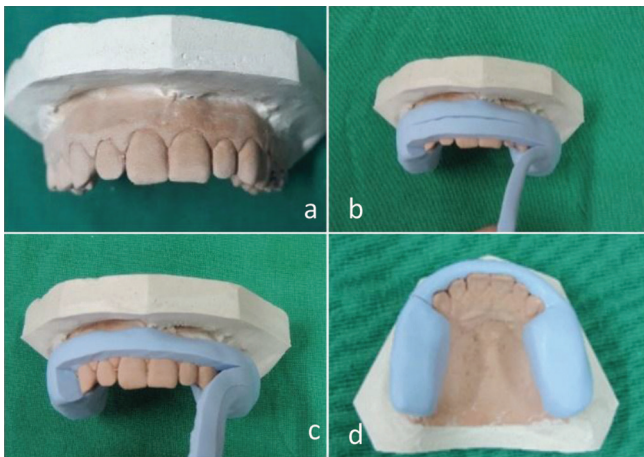
Figure-2: Pre-treatment intra oral pictures

A 21 years old female patient reported to the Department of Prosthodontics with the chief complaint of un-esthetic appearance due to discolored upper front teeth (Fig 2) and

spacing between upper lateral incisor and canine on both sides. Patient had no gross extra-oral facial deformity, muscle tenderness, TMJ pain and no deviation while opening and closing. Intraoral examination revealed moderate form of dental fluorosis with respect to upper and lower arch with fair oral hygiene. There was no interference in protrusive and lateral excursive movements. There was 2mm of over jet and over bite in maximum inter-cuspation position. Based on clinical and radiographic investigations, the case was diagnosed as moderate form of dental fluorosis (Fig 1) and taken up for rehabilitation with incisal lingual wrap type Porcelain laminate veneers for maxillary anterior teeth. (13,12,11, 21, 22, 23)

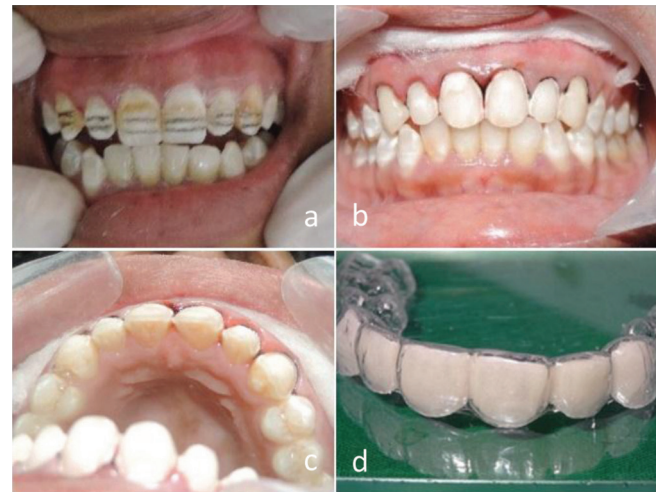
Figure-4: Bio-mechanical tooth preparation and temporization (Essex appliance)

porcelain bonding to enamel is better than porcelain bonding to dentin.⁴ Depth of grooves was marked with lead pencil (Fig 4a), which helps as a reminder to avoid over reduction. The finish line of the preparation was kept at the gingival level, approximately 0.5 mm incisal to cemento-enamel junction (CEJ).

Labial Reduction (Fig 4b) was done using a tapered diamond bur. Silicone reduction guide (Dentsply Aquasil soft putty) was used in order to check the amount of reduction required. The reduction guide was designed to evaluate the amount of

reduction at the incisal, middle third and cervical third of the tooth. A chamfer finish line was prepared 0.5 mm incisal to the CEJ at gingival level. Interproximal tooth reduction was extended till contact area without breaking the contact point to prevent tooth movement during temporization.

Incisal reduction (Fig 4c) was done with a 0.5 mm depth cuts on incisal surface of tooth. For Incisal Lingual Wrap Preparation the mesio incisal and the disto incisal corners were reduced an additional 0.5 mm. Then using a diamond bur, incisal chamfer was extended to the palatal surface. All incisal edges was kept rounded. The palatal chamfer line was kept above the centric lingual contacts to avoid occlusal contact on the interface between porcelain and tooth structure. Contact should be either completely on porcelain or on tooth structure.

Once the preparation was done, tapered finishing bur was used to finish the preparation without further reduction. Gingival retraction (Ultrapak USA) was done by placing a # 0 cord to reveal the margin, which was left in place while making the impressions using putty-wash impression technique. Polyvinyl siloxane (Dentsply Aquasil USA) impression materials were used according to manufacturer's instruction and impressions were poured twice with Die stone (Kalabhai Ultrarock) one to obtain master cast and second to obtain a cast for fabrication of temporary template. An Essex appliance was fabricated using a thermoplastic material over the pre-treatment diagnostic cast. Precision of the template was checked on second cast obtained after tooth preparation, separating media applied on cast, template filled with composite resin was placed over it and light cured (Fig 4d). Finishing and polishing of appliance was done, checked in mouth and seated.

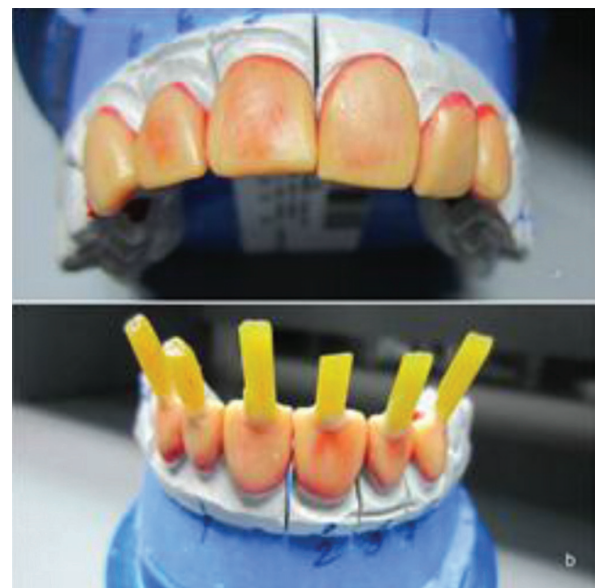
Figure-5: Lab procedures

IPS empress porcelain material was chosen because of its good esthetics and life like appearance. Lab procedures were carried out in form of wax pattern fabrication, spruing (Fig 5), investment and wax burn out. Porcelain furnace used for press able ceramics as per the guidelines. Provisional restorations were removed, tooth surfaces were cleaned and washed thoroughly without inducing gingival bleeding. The teeth were dried, isolated for try-in procedure. Veneers were

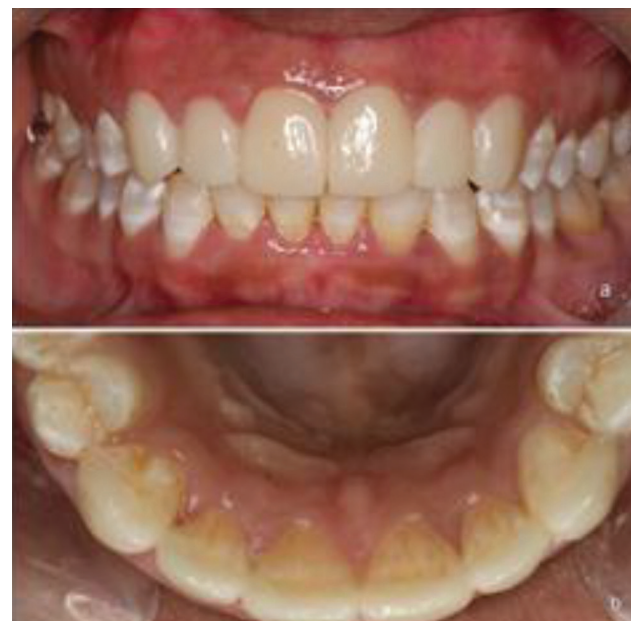
Figure-6: Post-treatment pictures

For cementation, inner surfaces of veneers were etched with hydrofluoric acid (CEREC 5% Hydrofluoric Acid Gel, VITA North America) for 20 seconds and Silane coupling agent (Kerr silane primer) was applied to the etched porcelain surface for 60 second followed by air-drying. Tooth surface was cleaned using pumice, dried and isolated. Prepared tooth surface was etched with 37% phosphoric acid for 30 seconds, rinsed thoroughly and air dried followed by bonding agent (Adper single bond 3M ESPE USA) application according to the manufacturer's instructions and was light cured. Dual cure resin luting cement (PANAVIA F 2.0) was applied to the inner surface of veneers and placed gently onto the tooth in an inciso-gingival direction. Excess cement was removed and light-cure was done at gingival margins first for 10 seconds, followed by all other surfaces. Final cure for 60 seconds was done through the facial surface. Excess cement were removed using sharp hand instruments. A layer of glycerine gel (Liquid strip- IvoclarVivadent) was applied along the veneer margins. Fine and extra fine diamond finishing burs were used to remove excess resin cement. Polishing was done to regain a smooth porcelain surface. Occlusion was checked in protrusive and lateral excursive movements and no interferences were found (Fig 6,7)
